HURRICANE

Katrina

IN THE GULF COAST

8. Overview of Hurricane Katrina in the New Orleans Area

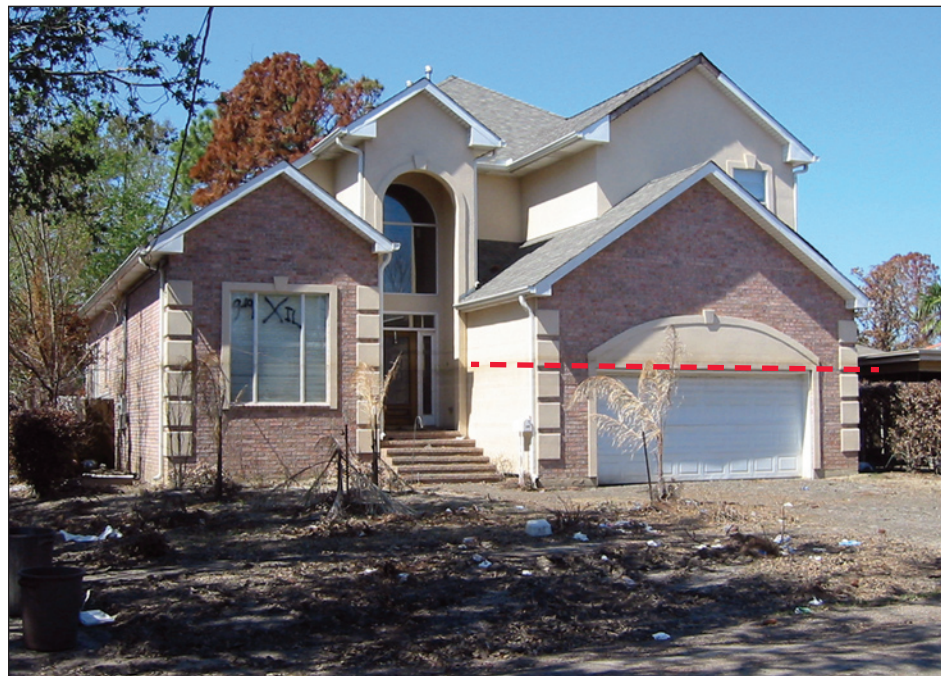
Figure 8-3.
Residential building
constructed
approximately 1 foot
above the BFE in
accordance with current
codes. Note flood depths
were even with the top of
the garage door, or about
3-5 feet above the first
floor (red line).

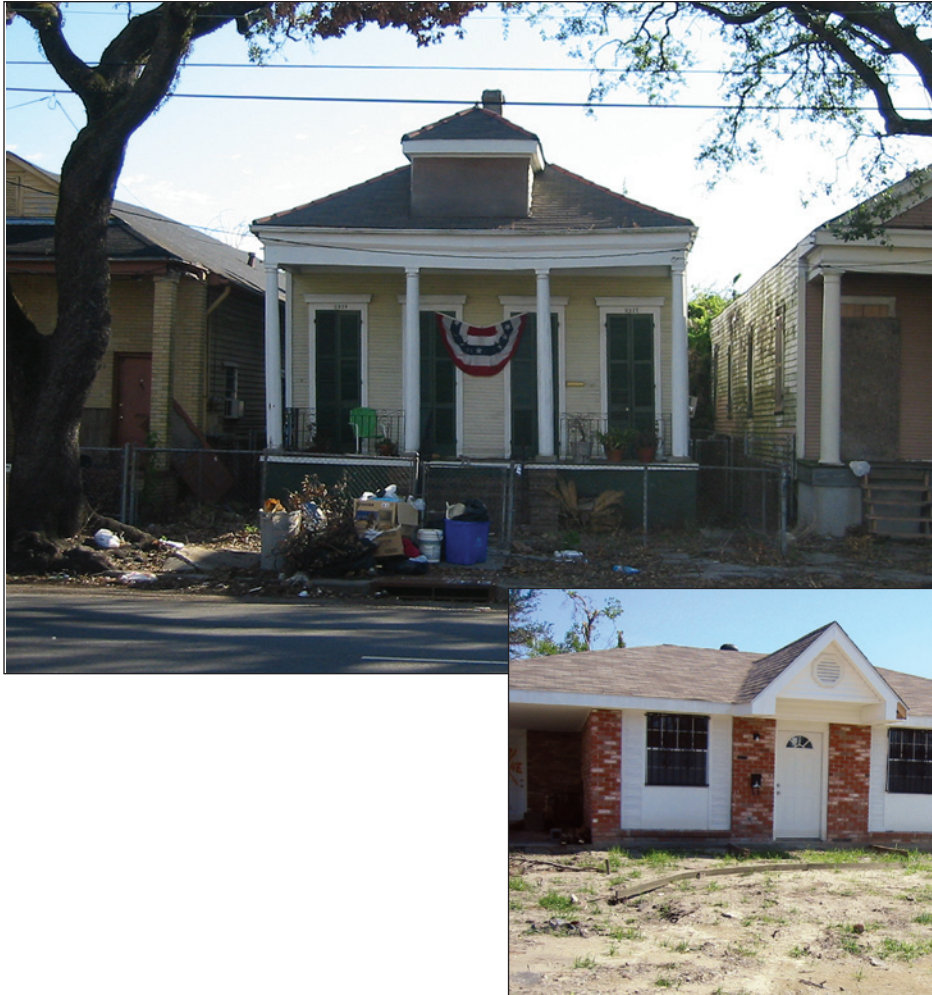
Figure 8-4. Comparison of building techniques in New Orleans. The older residence on the upper left has the first finished floor constructed several feet above grade. The newer residence on the lower right is constructed with a slab-on-grade foundation.

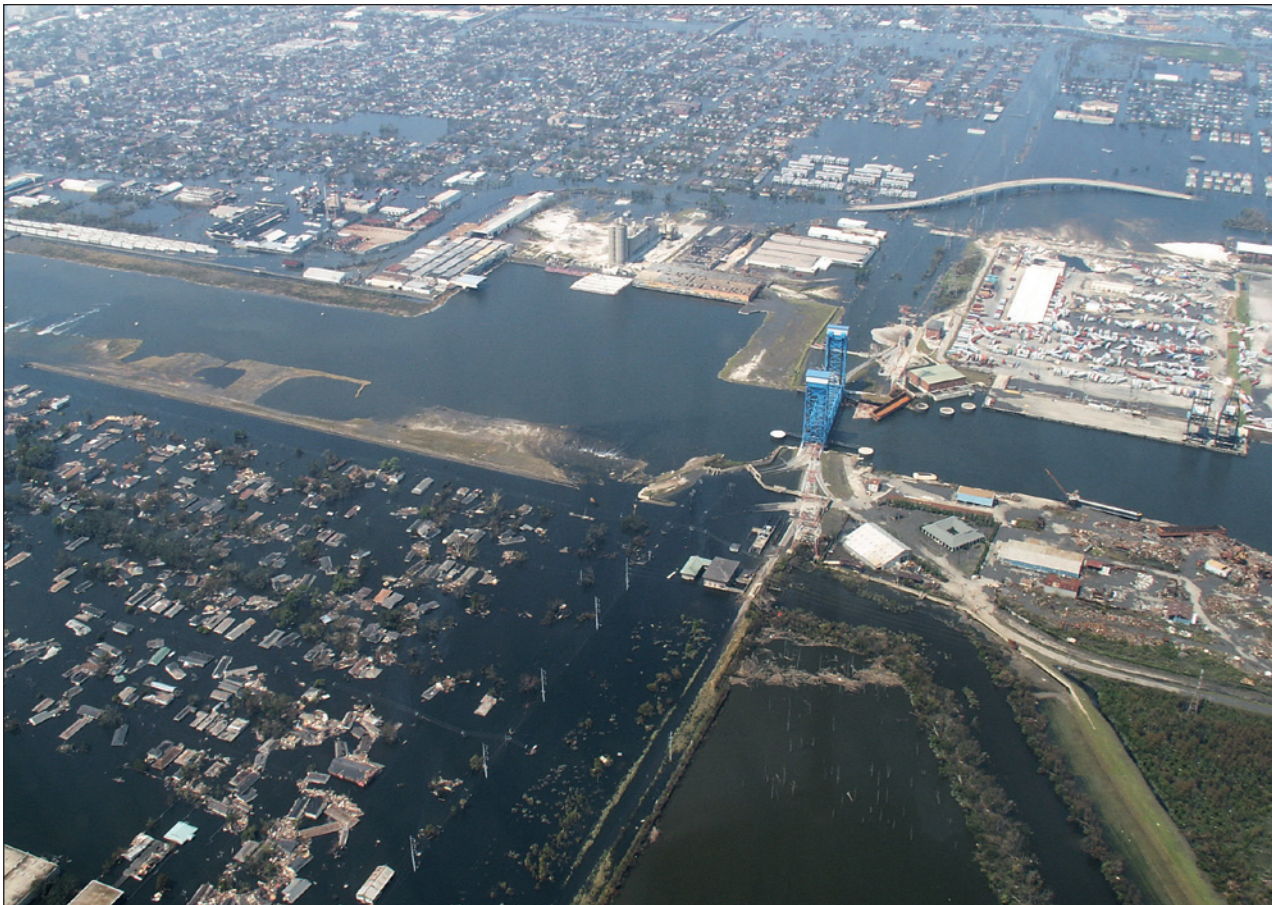
- First, the failure of the Industrial Canal (see Figure 8-5) and coastal levees produced intense flooding in eastern New Orleans and St. Bernard Parish, resulting in severe structural damage in the Lower Ninth Ward of New Orleans and Chalmette in St. Bernard Parish. Observations by the New Orleans Flood team indicated widespread destruction of

residential buildings in the Lower Ninth Ward from high velocity floodwaters and strong winds, waves, and high floodwaters that knocked buildings off their foundations, collapsed load-bearing walls, and caused other structural failures.

Figure 8-5. The Industrial Canal levee breach in New Orleans

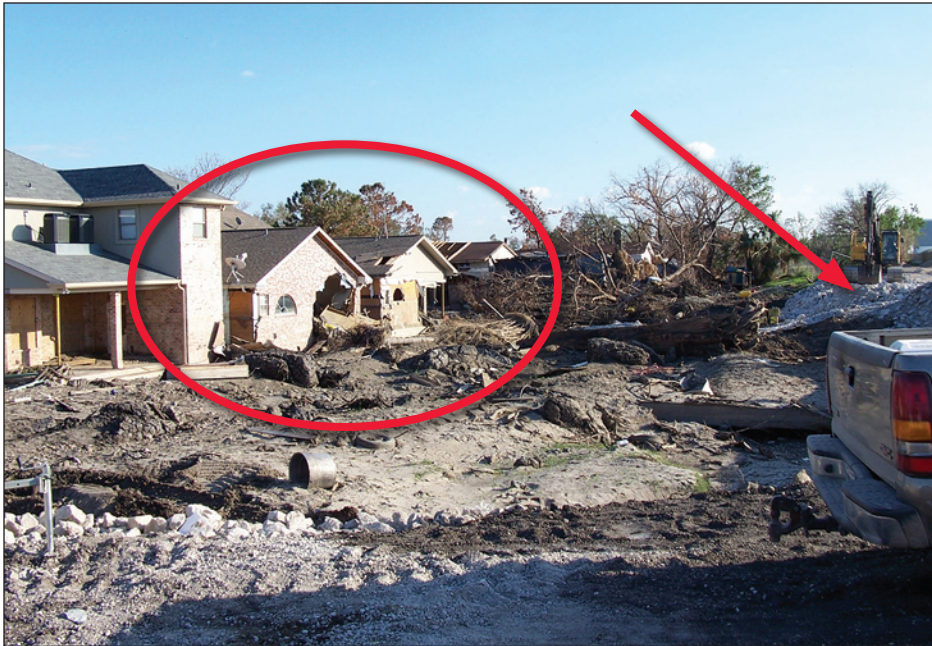
- Second, residential buildings sited immediately behind failed sections of levees or other flood control structures such as the 17th Street Canal levee breach suffered significant structural damage, failure of load-bearing walls, and excessive scour around slab foundations from large hydrodynamic forces generated by the levee breach (see Figure 8-6). However, these forces and impacts were quickly dissipated within a few blocks of the breach.

Figure 8-6.
Structural damage to residential buildings (circle) in New Orleans located immediately behind the site of 17th Street Canal levee breach (arrow)

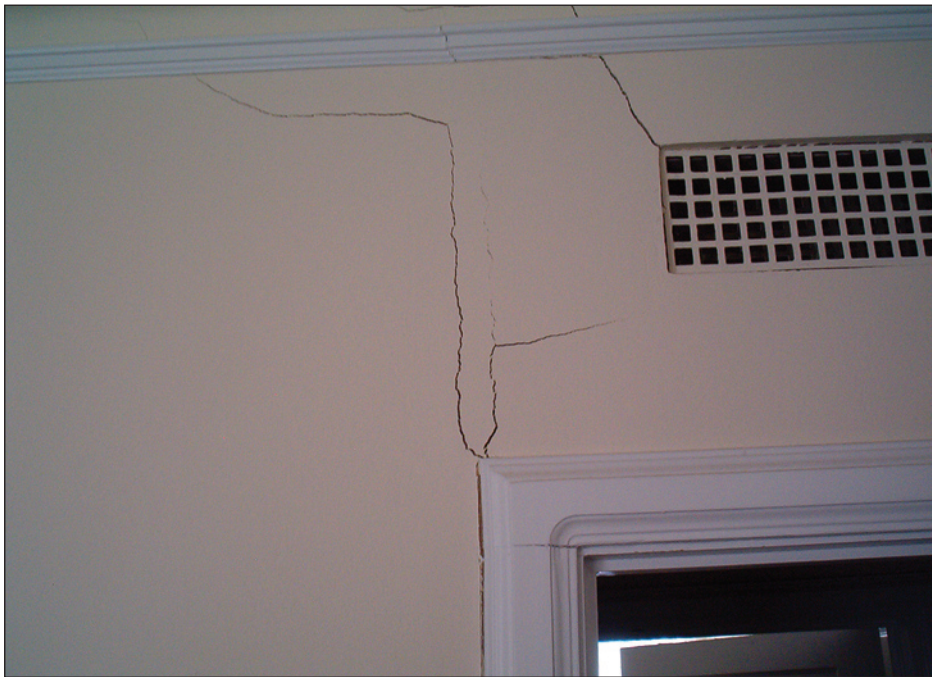
- Third, buildings sited on poor foundation soils suffered significant structural damage and cracking of load-bearing walls and sagging floors due to subsidence or differential settlement of saturated soils that support one or more foundation walls and/or piers (see Figure 8-7). While most of the observed structural damages triggered by soil settlement or subsidence did not constitute an imminent danger of collapse, such damages (and the underlying soil problems behind them) typically require analysis by a foundation engineer and can be expensive to isolate and repair.

Figure 8-7.
Settlement cracks in upper floor wall of New Orleans residence due to subsidence/differential settlement of underlying foundation soils during long-duration flooding

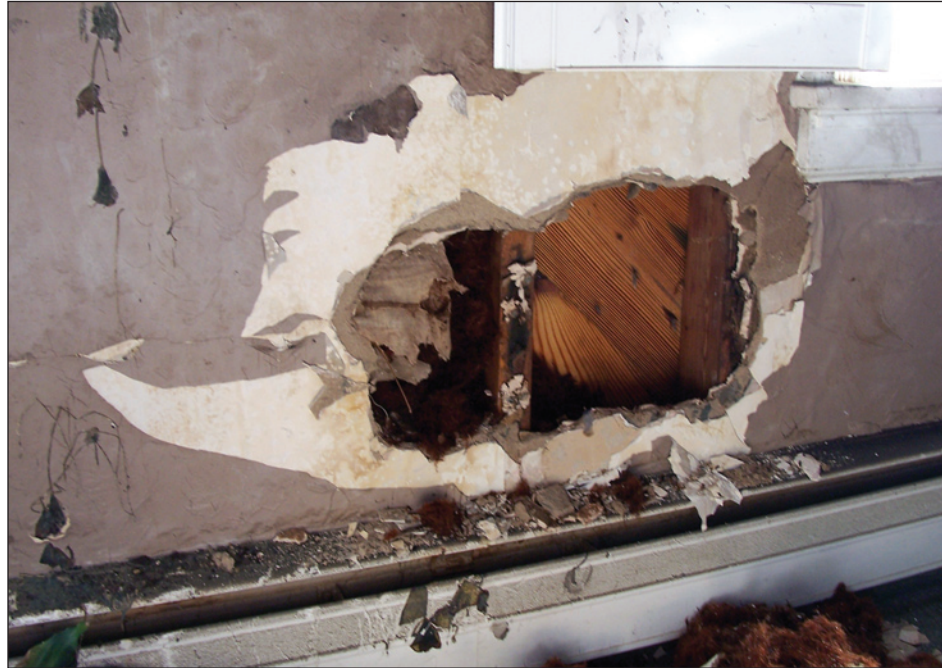
Figure 8-8.
Exposed wall studs and sheathing boards in 74-year-old New Orleans residential building, showing no significant deterioration from long-duration flooding

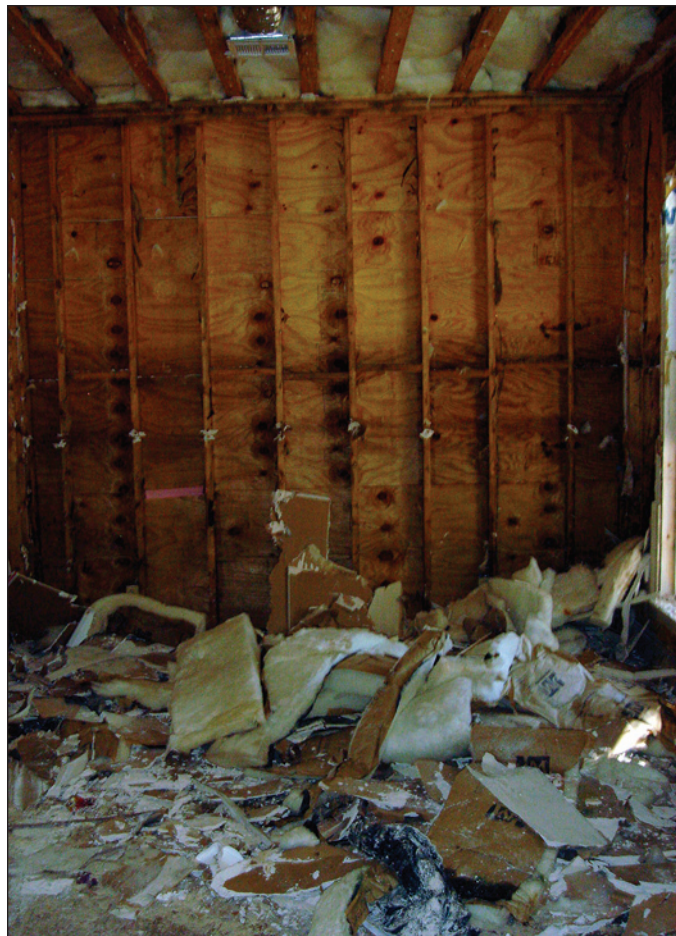
Figure 8-9.
Exposed wall studs and sheathing boards in 2-year-old New Orleans residential building, showing no significant deterioration from long-duration flooding.

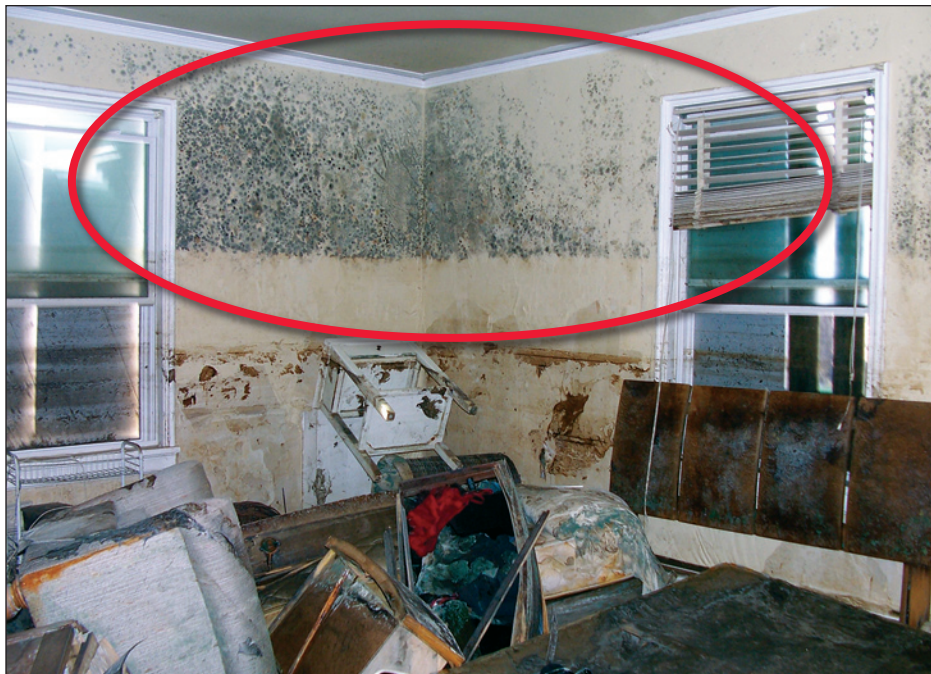
Figure 8-10.
Typical interior flood damage to residential building in New Orleans, showing extensive mold growth (circle)

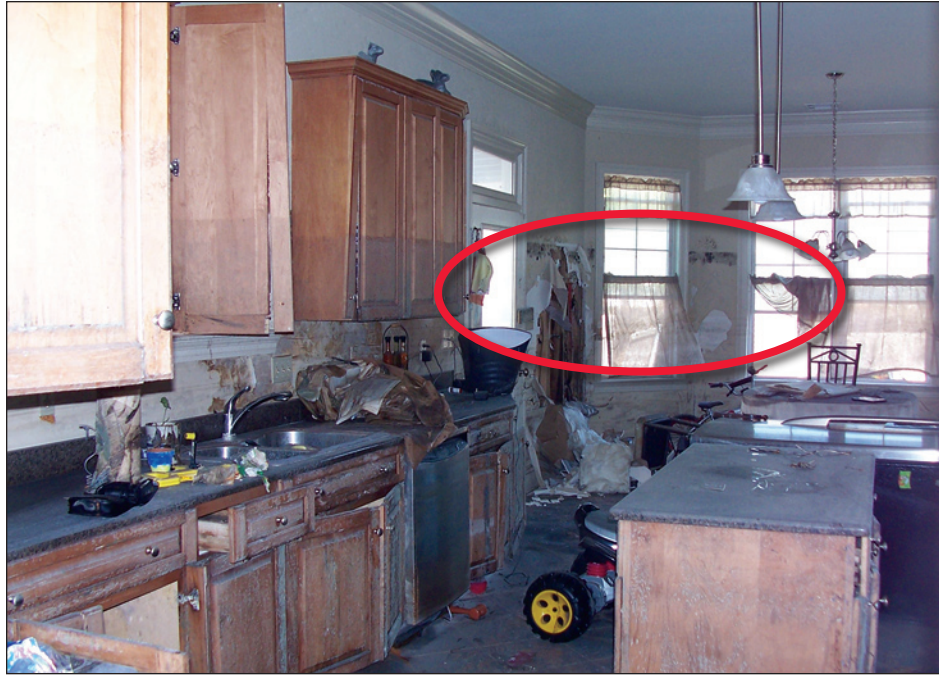
Figure 8-11.
Typical interior flood damage to residential building in New Orleans, showing light mold growth (compare to Figure 8-10)

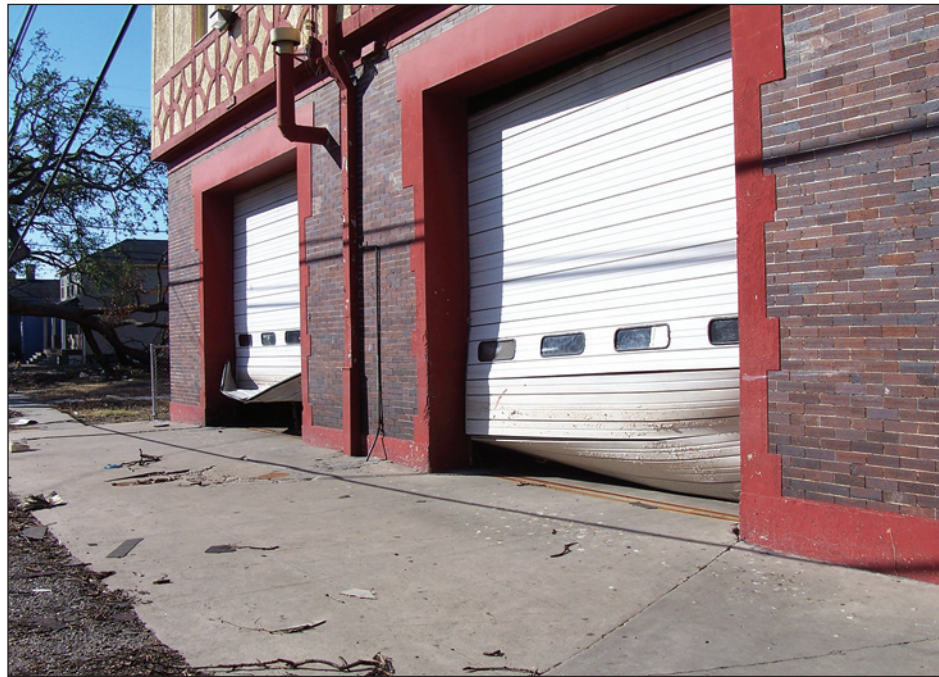
Several fire stations in New Orleans suffered flood damage to garage bay doors (see Figure 8-12). The fire stations in New Orleans observed by the MAT did not contain fire trucks or other heavy equipment; these appear to have been relocated prior to the flood. Many New Orleans hospitals suffered interior damage such as collapsed drop ceilings due to a loss of emergency power generators, which shut down HVAC systems used to control temperature and humidity. In some hospitals, the loss of emergency generators resulted from flooding of the generator controls or the fuel storage tanks (see Figure 8-13). However, in most hospitals, the loss of emergency generators occurred as a result of mechanical breakdown from extended use following Hurricanes Katrina or Rita.

Figure 8-12.
Damage to garage bay doors at fire station in New Orleans. The door on the right was pushed in by flooding; the door on the left appears to have been pulled open from the outside by looters.

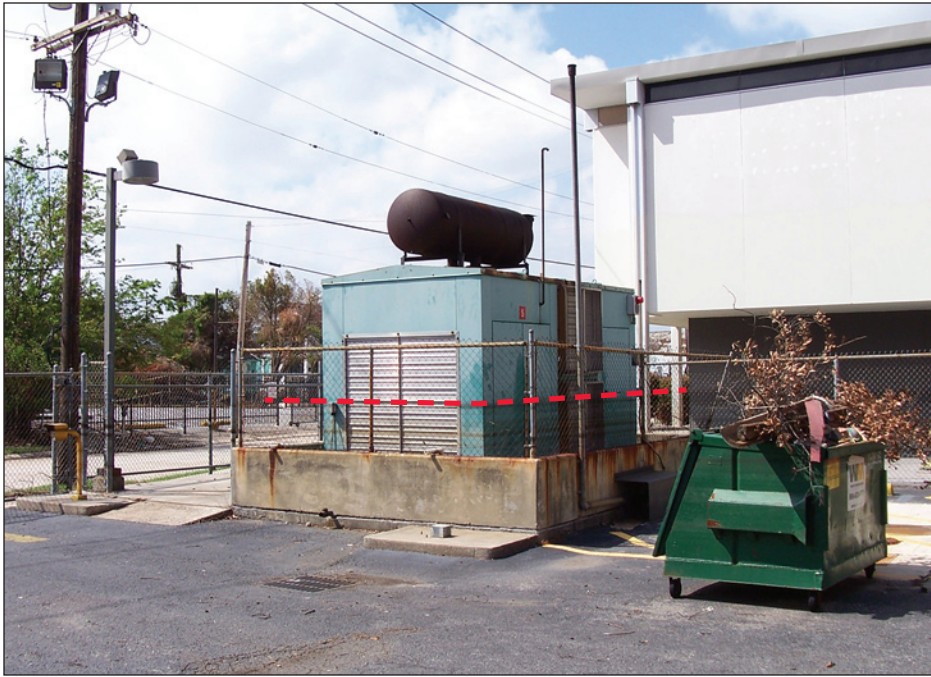
Figure 8-13.
Flooded emergency
generator at hospital in
New Orleans (note flood
line in red)

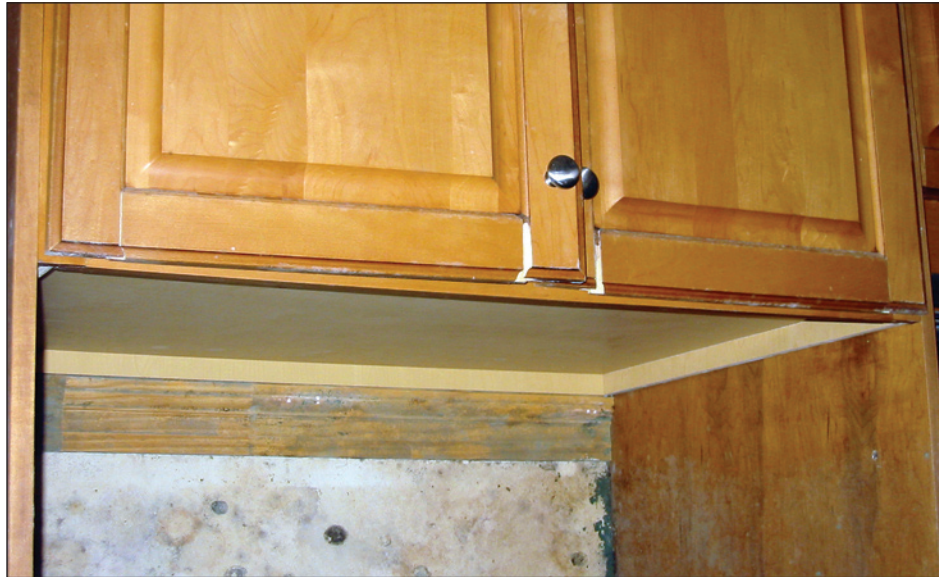
Figure 8-14.
Kitchen cabinet doors
above the flood level
were damaged from the
excessive moisture in the
house from long-duration
flooding.

- **Interior doors and cabinets.** The majority of interior doors and cabinets observed in New Orleans buildings were constructed of laminated wood products. The water vapor migration that occurred throughout many building interiors caused countless laminated wood passage doors, and cabinet doors and drawers to swell shut (see Figure 8-14).

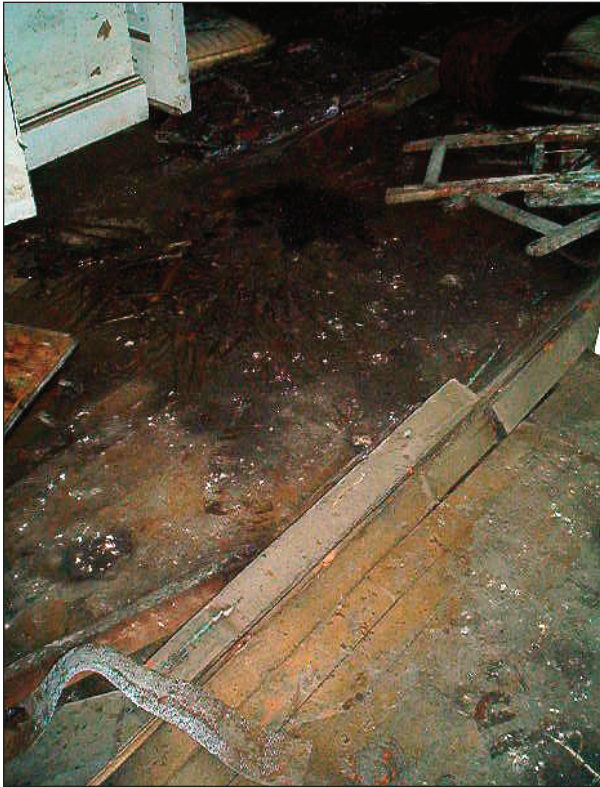
Figure 8-15.
Flood residue and buckled floor observed on General Diaz Street. A sample of the flood residue was collected for analysis.

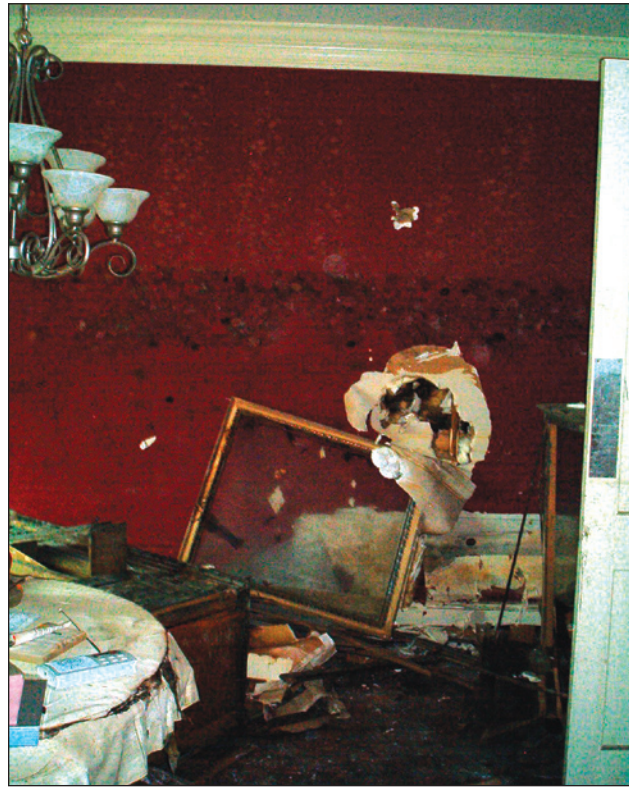
Figure 8-16.
Samples were collected from wall materials both above and below the waterline as shown on this wall of a house on Memphis Street. Where practical, samples were collected from surfaces that were already substantially damaged or scheduled for tear-out.

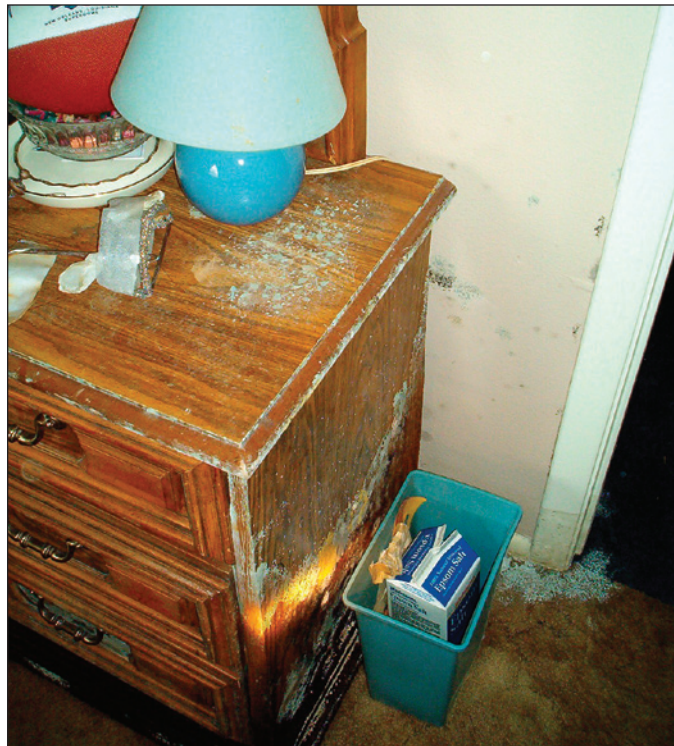
Figure 8-17.

Bacteria levels were frequently found to be significantly lower in areas with rampant fungal growth. This pattern held true at the residence on Savoie Court, where fungal levels were extensive on the dresser and carpet near the door frame while the bacteria levels were negligible at these same locations.

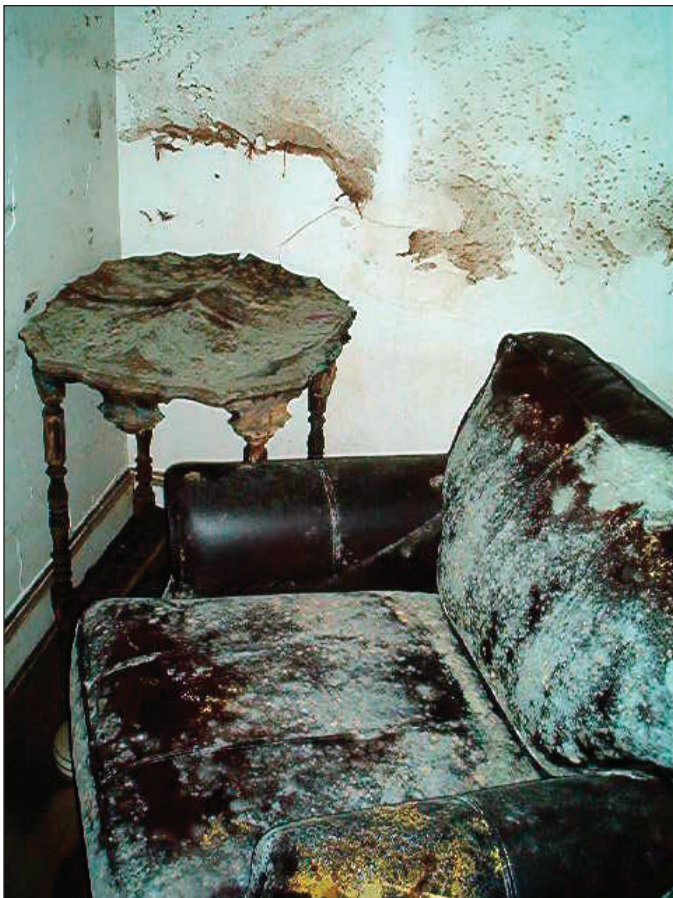
Figure 8-18.
Prolific mold growth was seen on porous contents in most inspected buildings.

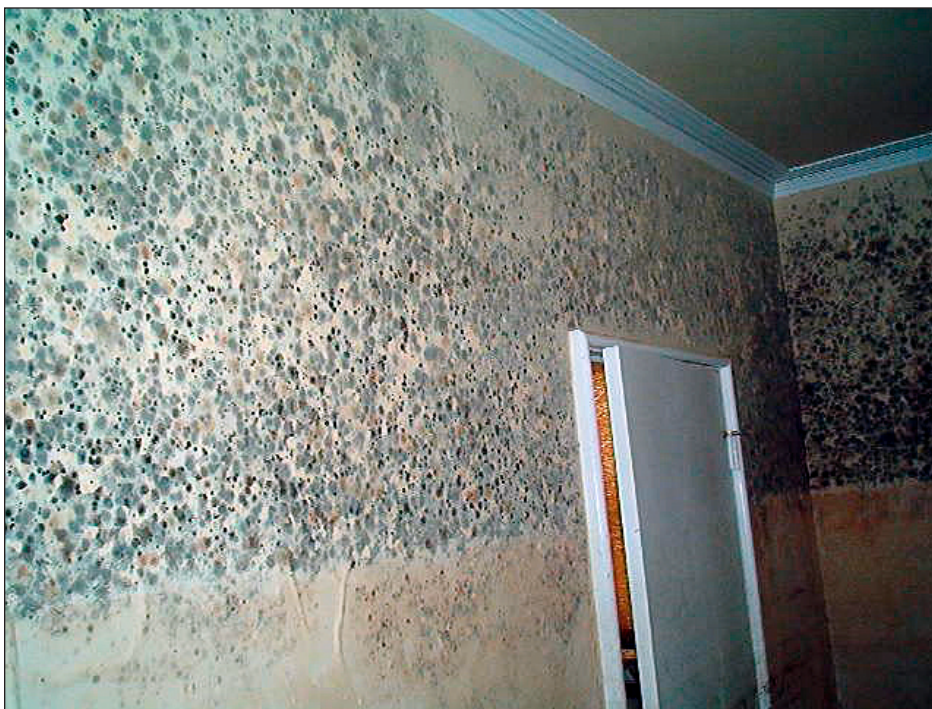
Figure 8-19.
The mold growth on the walls was generally much more vigorous above the floodwater level than below it. Sediments, heavy metal contamination, and oil film residue, as well as material moisture content and lack of exposure to air during flooding, may contribute to minimizing the fungal growth on the saturated wall materials.

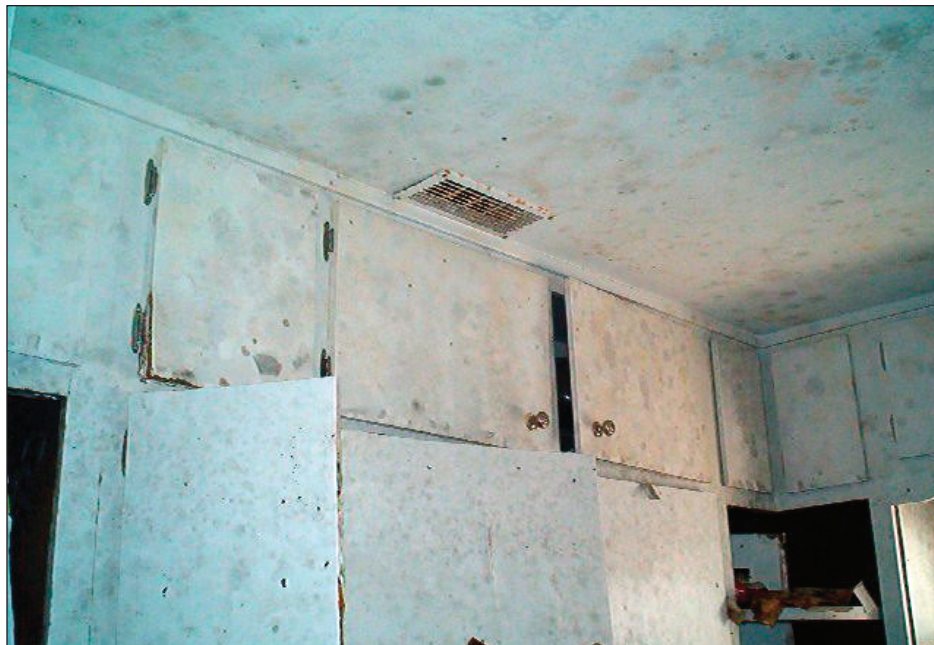
Figure 8-20.

In many buildings, the mold growth above the waterline appears to have been fueled by condensation of moisture in addition to water “wicking.” The upper cabinets and kitchen ceiling in the building on General Diaz Street were well above the floodwater line, yet showed extensive fungal growth.

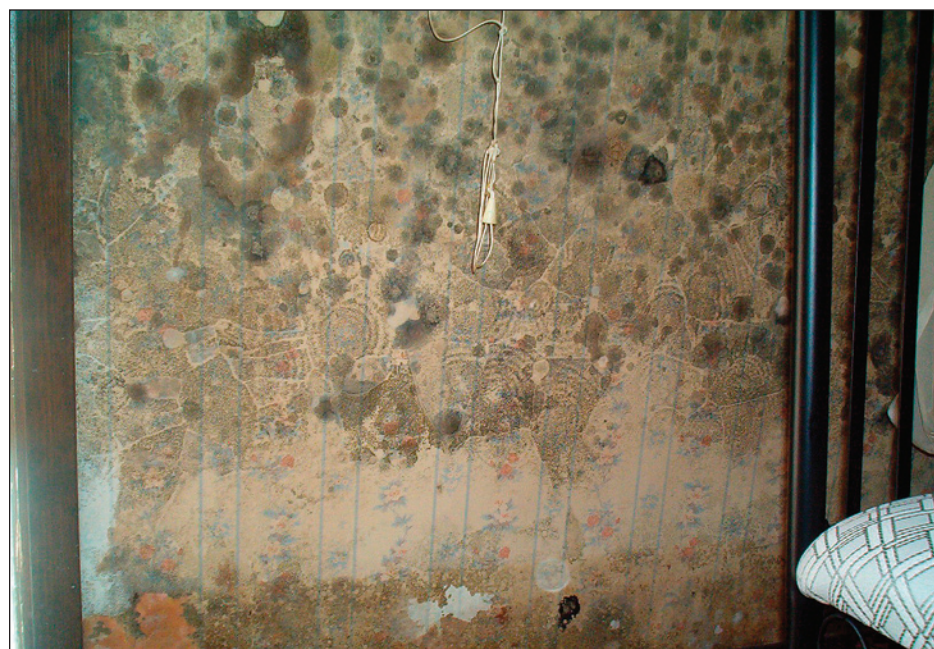
Figure 8-21.

On Savoie Court, fungal growth was observed up to the ceiling on some walls, despite the fact that floodwaters only reached up 18-24 inches. This wall showed thick mold growth both above and below the high water mark.
